FEM PARAMETERS – RIVER SAVA

AFP01 – 1

100-year return period

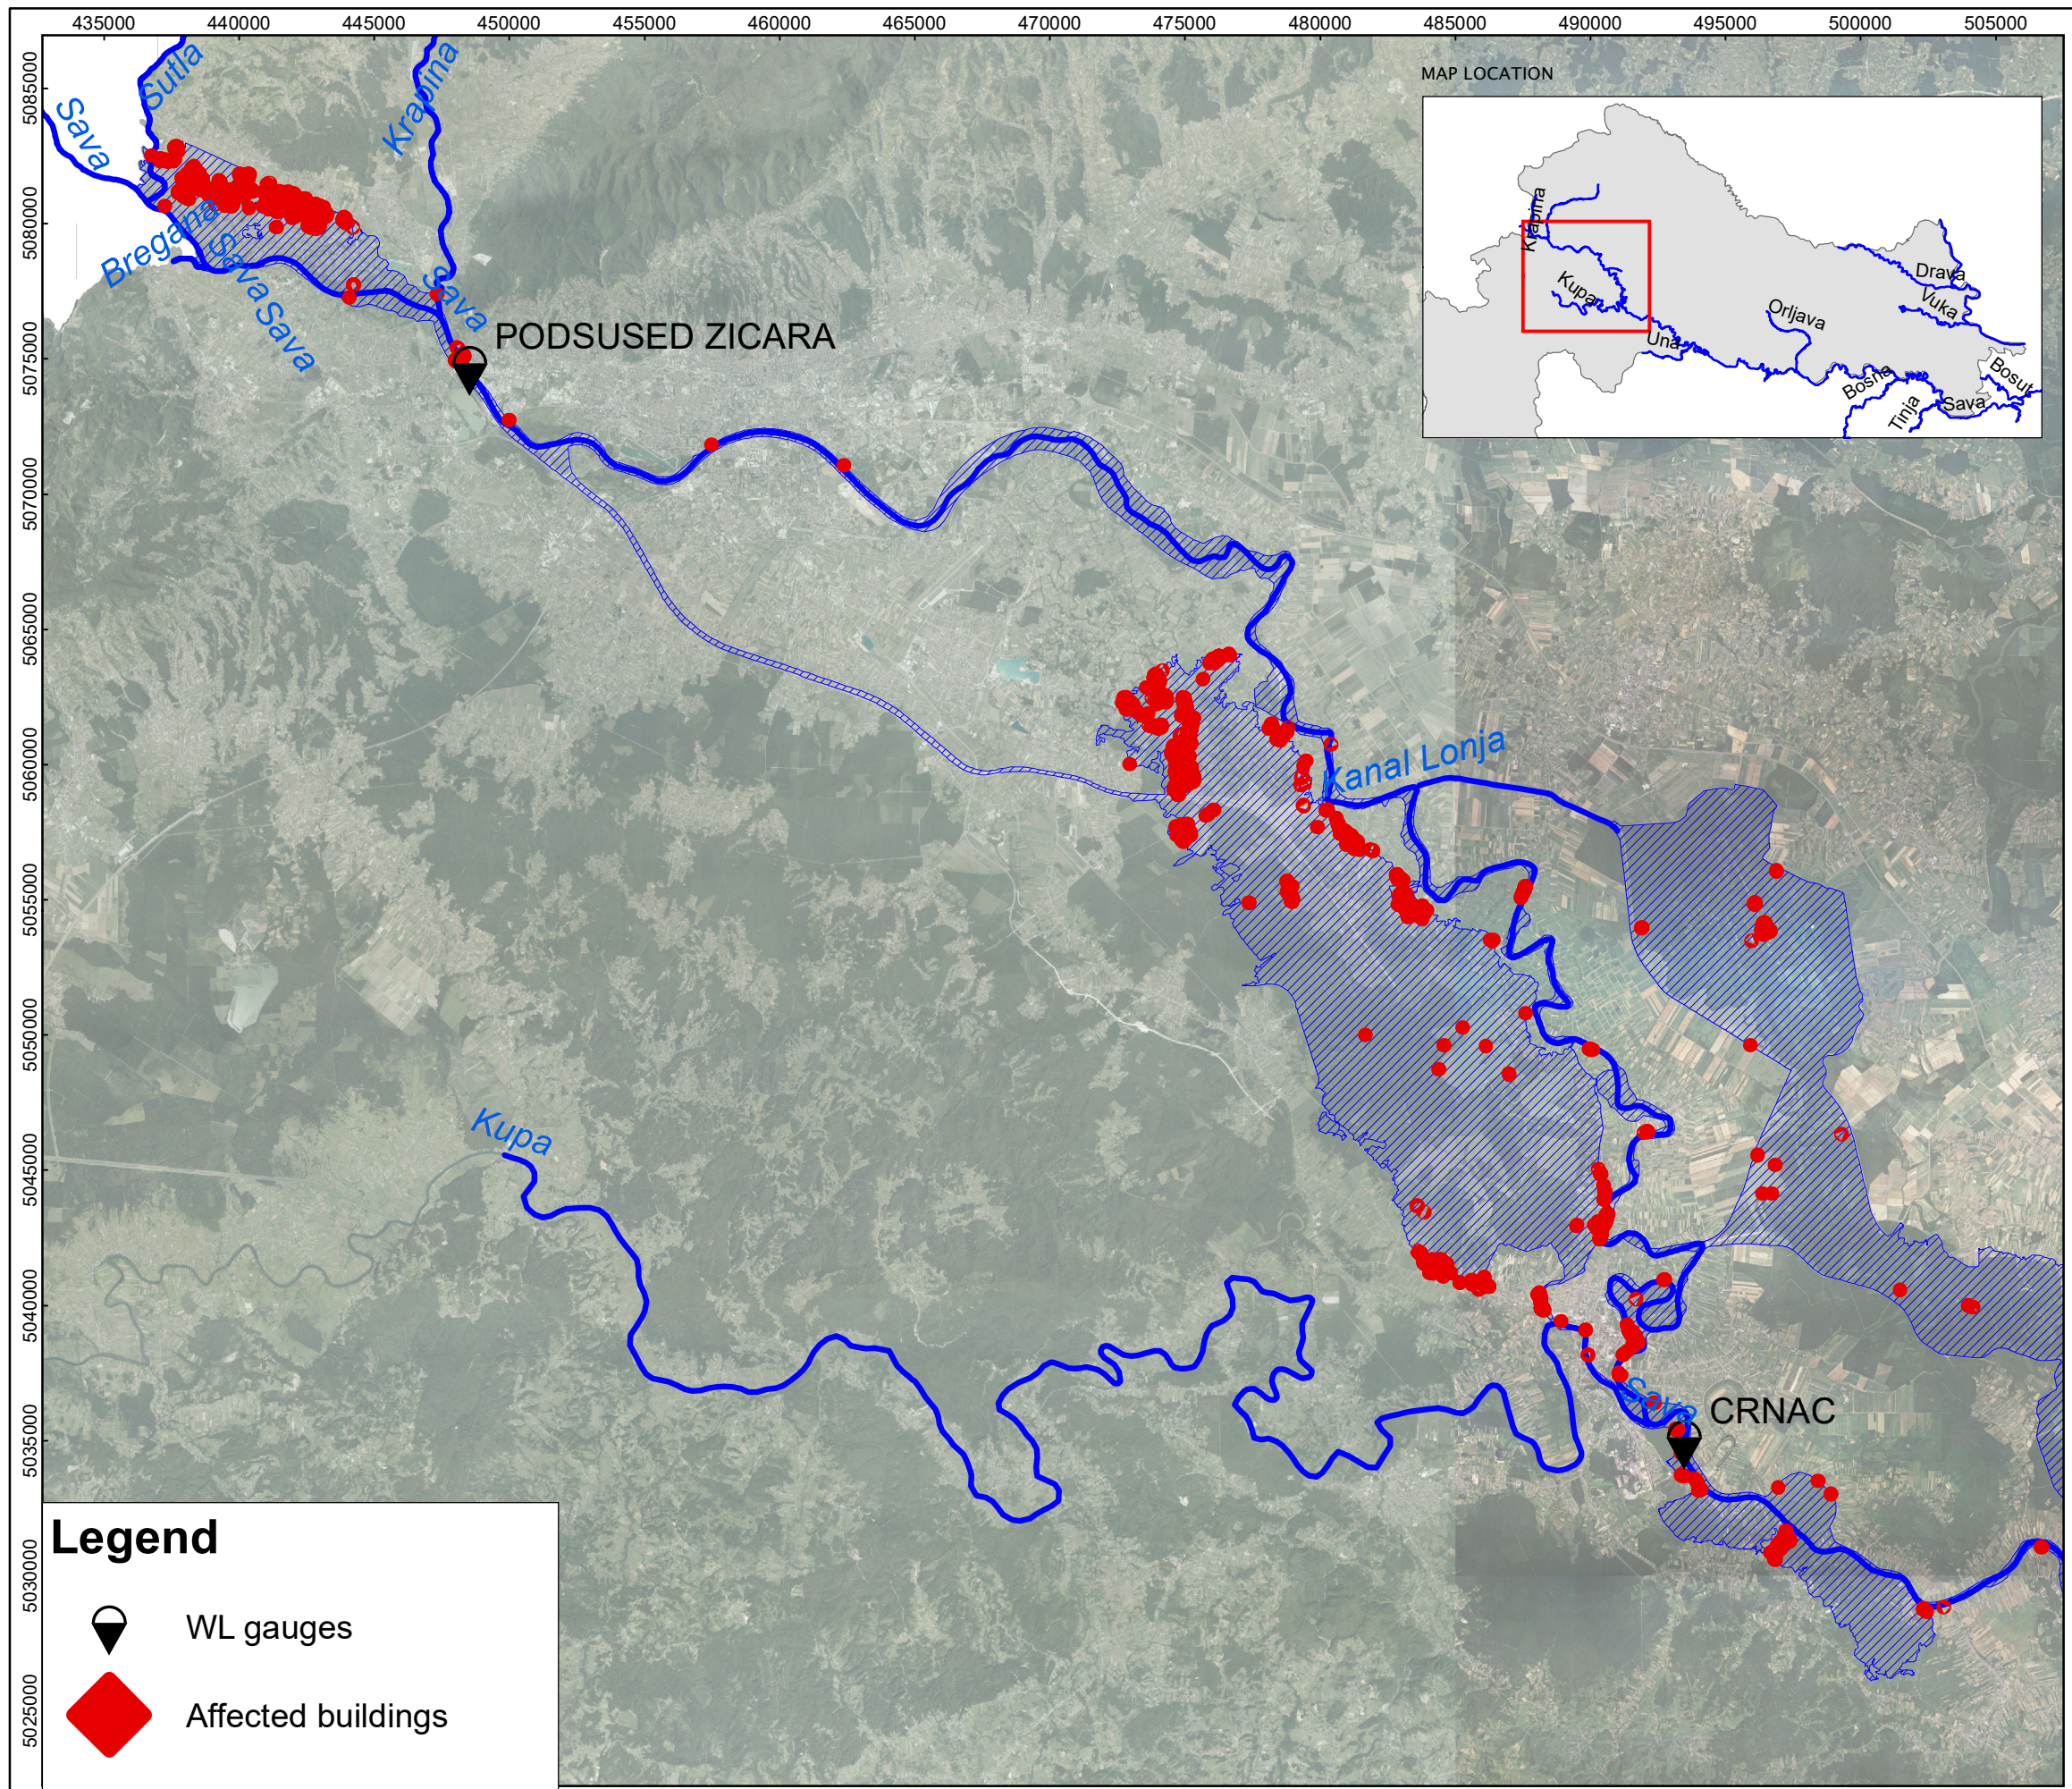
- WL gauges
- Affected buildings
- Rivers
- Flood Zone extent (AFP)

- Design flows $Q_{100} = 3489 \text{ [m}^3\text{/s]}$
 $Q_{\text{bankfull}} = 1733 \text{ [m}^3\text{/s]}$

$\Delta Q \text{ [m}^3\text{/s]}$	$\Delta Q_{\text{rel}} \text{ [%]}$	FEM Class
1398.77	79.67	5

$\Delta h \text{ [m]}$	FEM Class
4.43	5
