FEM PARAMETERS – RIVER SAVA

AFP01-2

100-year return period

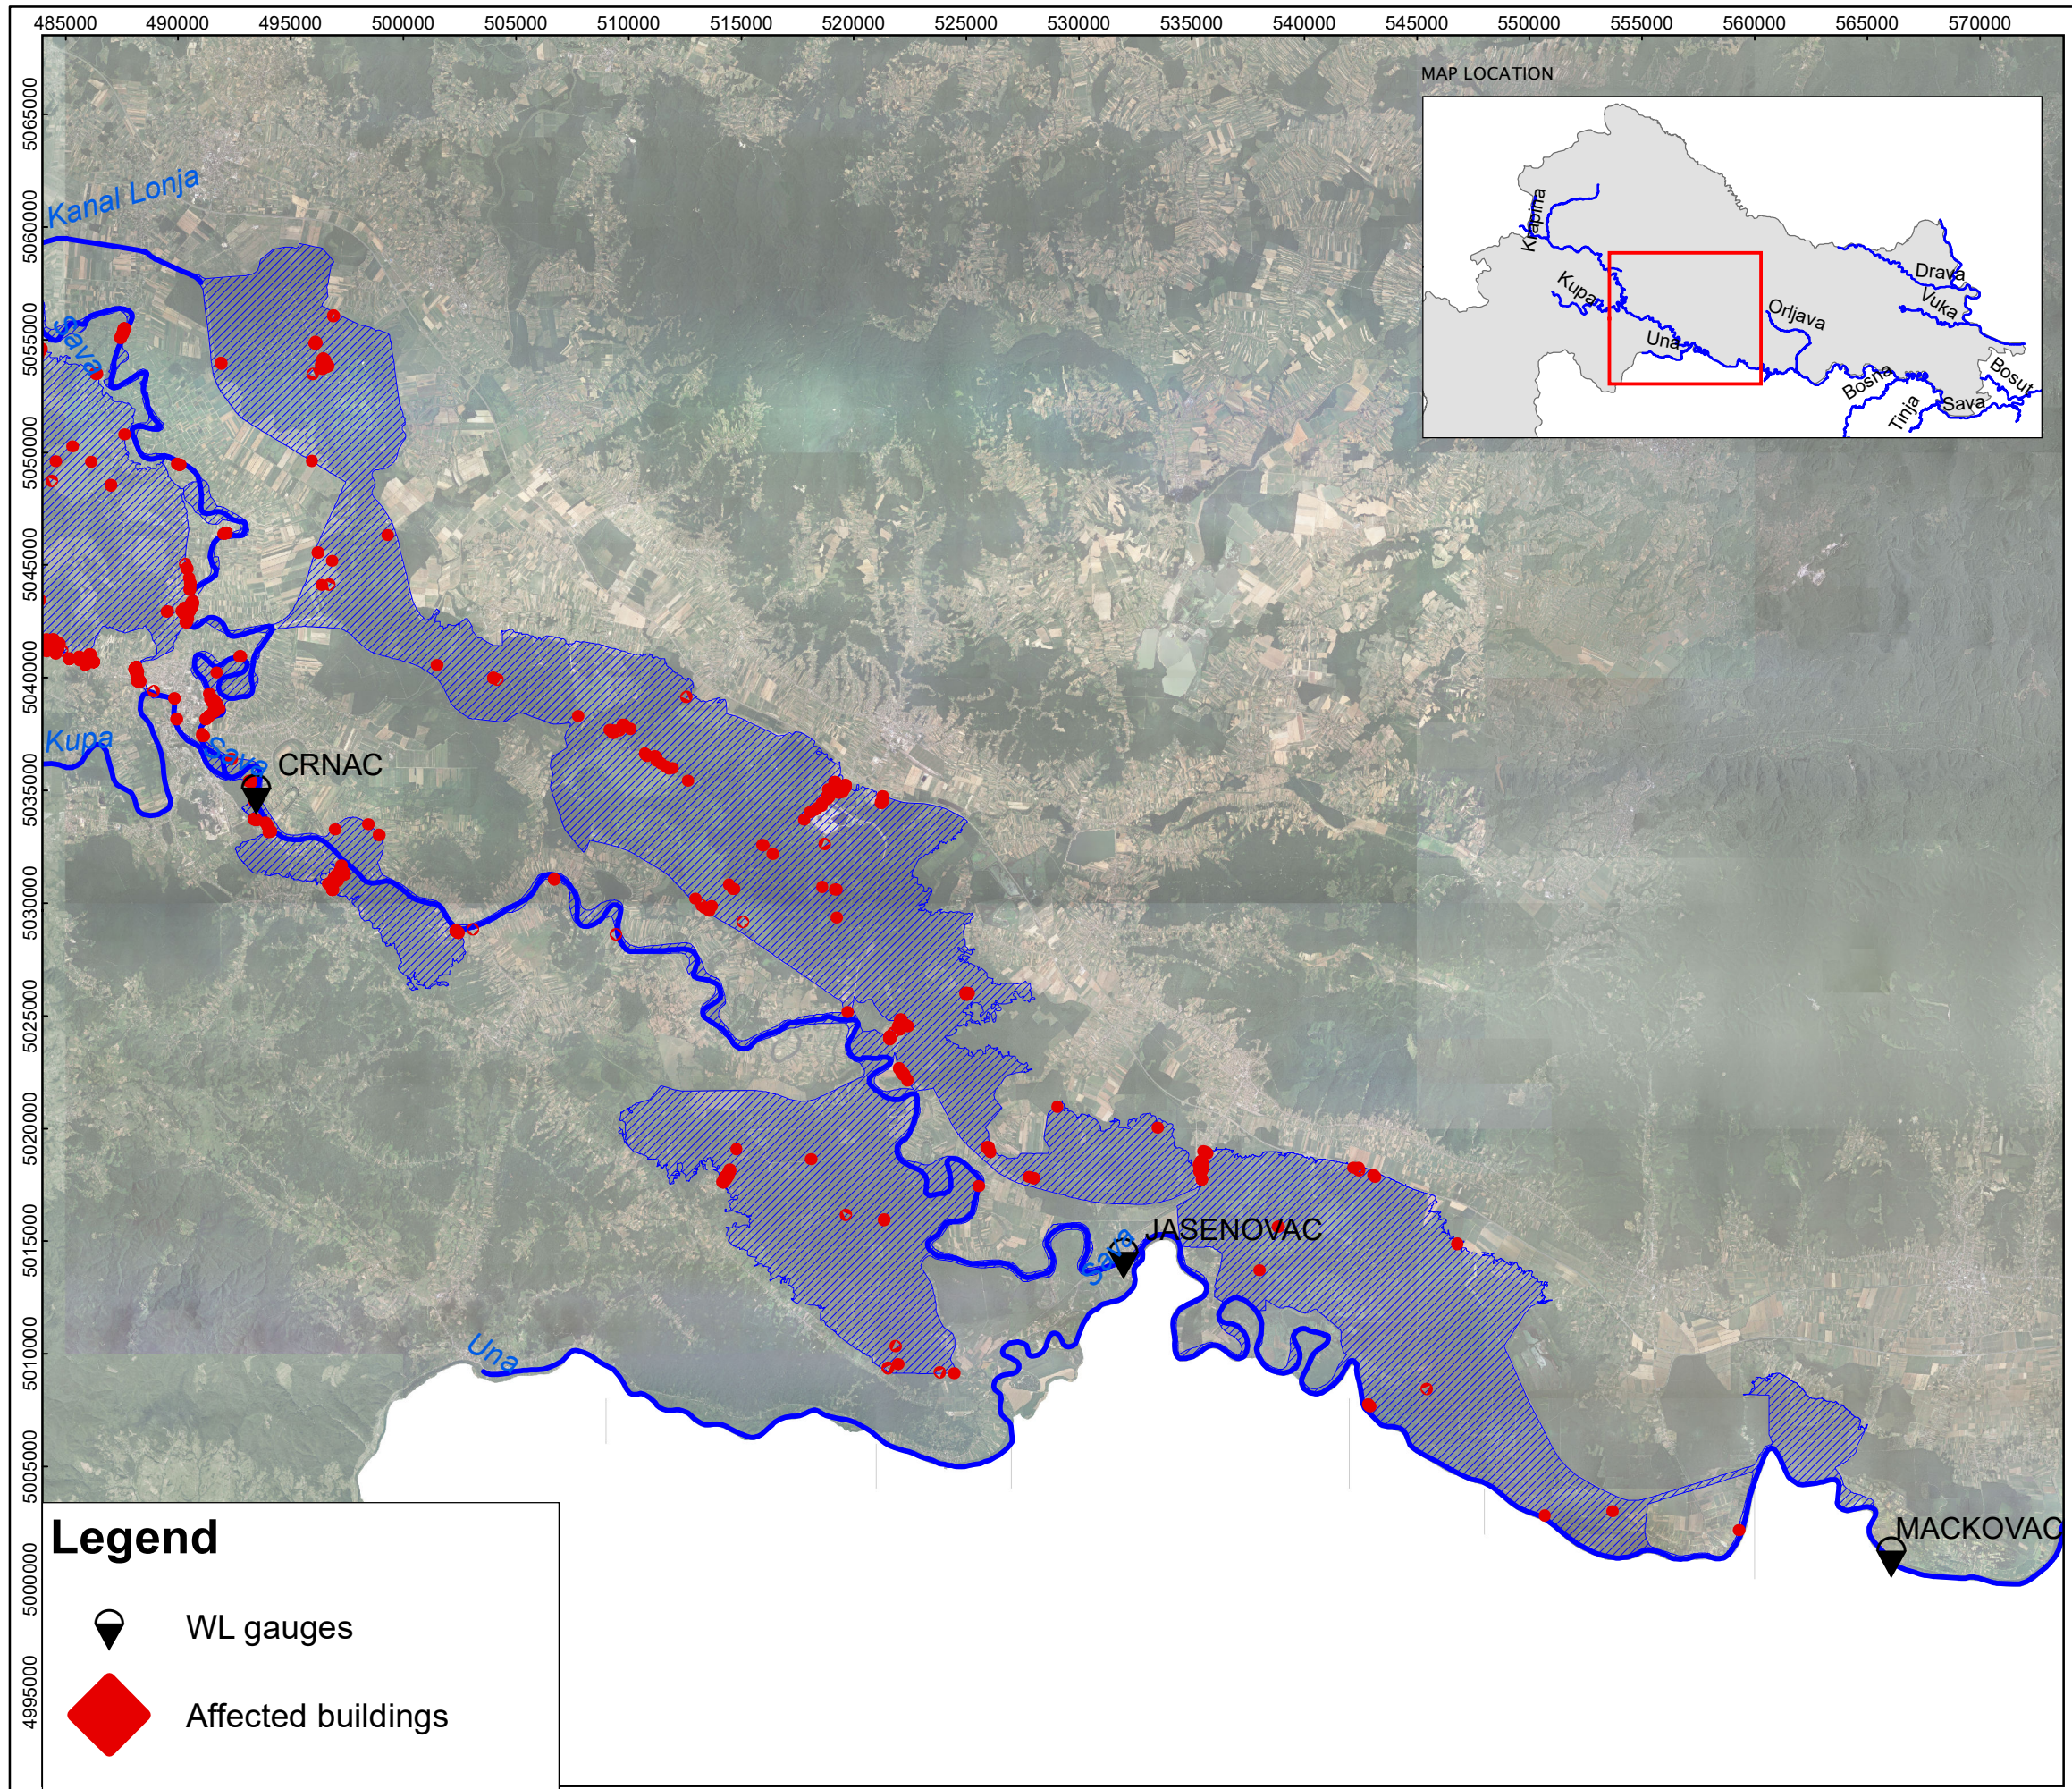
- WL gauges
- Affected buildings
- Rivers
- Flood Zone extent (AFP)
